Joint Inter-Korean Excavation of Kaesong Manwoldae

Figure 4. The Plot Plan of the Western Building of Kaesong Manwoldae

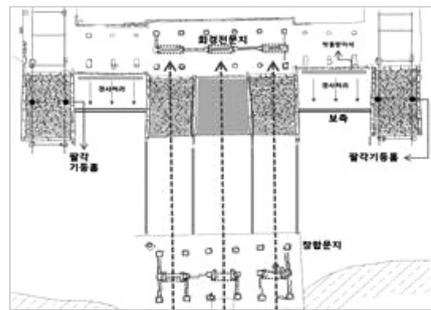
Figure 2. Circulation Path Connecting Changhapmun Gate, Stairs of Hoegyeongjeon Hall, and Hoegyeongjeonmun Gate (Changgeun Nam and Seong-jin Ji 2019)

In the ancient palace system, gates provided the space in which not only the process of reaching the central area of the palace but also ritual ceremonies were held. Also, there was a distinction between the number of gates allowed in the space of an emperor and that in the space of feudal lords. In Gyeongbokgung Palace—the main palace of Joseon Dynasty—the entrance space consists of Gwanghwamun Gate, Heungryemun Gate, and Geunjeongmun Gate to reach Geunjeongjeon Hall, the main hall. In contrast, in Kaesong Manwoldae, more gates were installed to realize the identity as an imperial palace and emphasize the depth and hierarchy of the central area. The process of reaching the main hall—Hoegyeongjeon Hall—by climbing the steep stairs and going through the Hoegyeongjeonmun Gate creates a dramatic effect by fully utilizing the topographical characteristics of this site.

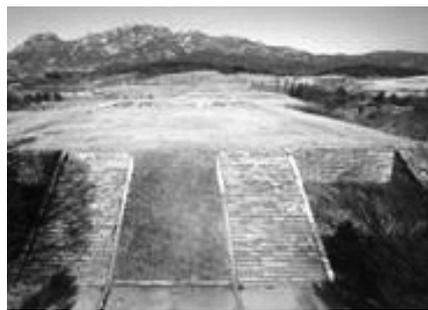
Figure 3. Central Group of Buildings and Stairs in Front of the Hoegyeongjeon Hall

The main halls of the central building group include Hoegyeongjeon Hall 會慶殿, Janghwajeon Hall 長和殿, and Wondeokjeon Hall 元德殿. According to literary records, in particular, the Hoegyeongjeon Hall—the main hall—is a place to receive the envoy of Song, receive reports, or hold royal Buddhist and Taoism ceremonies. However, the Hoegyeongjeon Hall was mentioned in the records only after 1029 (the 20th year of King Hyeonjong's reign), so it can be presumed that it was built during the reconstruction of the palace from 1020 (the 11th year of King Hyeonjong's reign) to 1023 (the 14th year of King Hyeonjong's reign). Except for the Hoegyeongjeon Hall, the name of other buildings appears only in *Goryeodogyeong* 高麗圖經, but it cannot be found in *Goryeosa* 高麗史, so it is difficult to accurately identify the details of them or the time period.

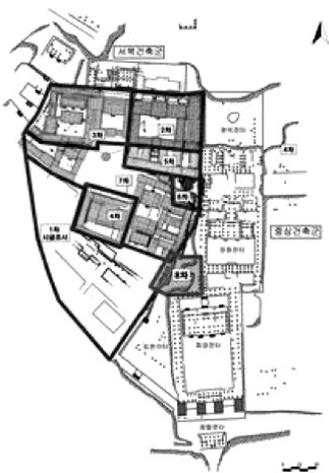
Table 1. Timeline of the Joint Inter-Korean Excavation in Kaesong Manwoldae

Term	Survey Period	Survey Area	Major Outcomes	Site Map
1 st	May-July 2007 (60 days)	western group of buildings 33,000 m ²	40 building sites, embankment, drainage channels

2 nd	September-November 2007 (75 days)	site of building group no. 1 3,000 m ²	5 building sites, embankment	
3 rd	November-December 2008 (50 days)	site of building groups no. 2 and 3 3,600 m ²	10 building sites, Gyeongryeongjeon Hall identified	
4 th	March-May 2010 (57 days)	estimated Geondeokjeon Hall site 3,600 m ²	5 building sites	
5 th	November-December 2011 (37 days)	emergency restoration site of building group no. 4 1,280 m ²	emergency restoration investigation, connections of building group no. 1	
6 th	July-August 2014 (25 days)	site of building group no. 5 220 m ²	Large stairs, drainage channels	
7 th	June-November 2015 (183 days)	site of building groups no. 6, 7, and 8 7,000 m ²	20 building sites	
8 th	October-December 2018 (50 days)	embankment of Hoegyeongjeon Hall 1,070 m ²	large stairs, site of corridors

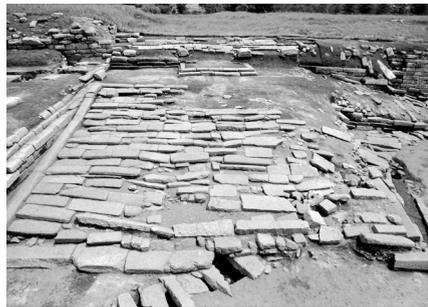
Figure 5. Large Stairs 1

Meanwhile, as the flat surface meets the embankment on a north-south axis, two large stairs connect the central and western building groups. The large stairs in the north is located on the north side of the Janghwajeon Hall in the central group, and the large stairs in the south is located on the north side of the Hoegyeongjeon Hall, providing a circulation path connected to the western building group. However, there is a difference in shape. The height of the embankment is not high in the north, but the height difference increases as it descends to the south. Therefore, the stairs in the north are 2.5 meters in height (13° inclination) and constructed as a protruding shape attached to the embankment. The stairs in the south, however, are 5 meters in height (37° inclination) and built in the embankment. On the other hand, it is common that a drainage channel is built at the bottom of the stairs, so that it is connected to the north-south drainage channel constructed in parallel with the north-south embankment.

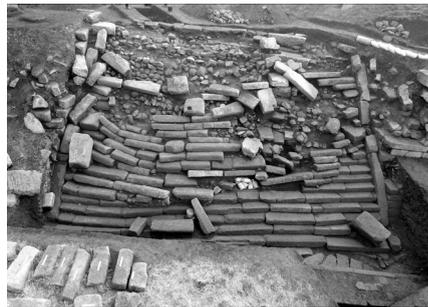
Figure 6. Large Stairs 2
